WEST TUSCALOOSA
Community Inventory

Blight Study

Introduction

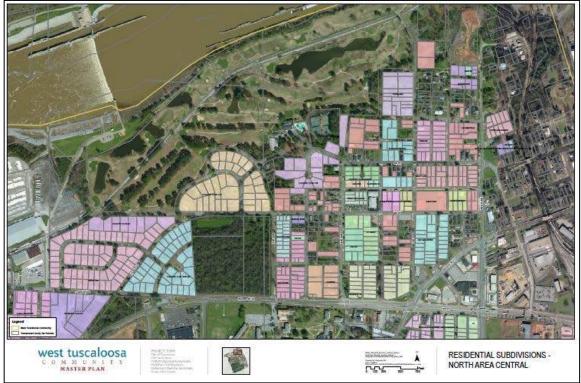
Figure 3. North Area Central

While blight conditions appear throughout the West Tuscaloosa Study Area, the Consultant Team focused site visit efforts in areas of concentrated blight conditions. The West Tuscaloosa Study Area is approximately 10 square miles in size. Therefore, efforts to document conditions of blight were focused in the following target areas, as depicted in Figures 3, 4, and 5 below: North Area Central (north of Stillman Boulevard and west of Martin Luther King, Jr. Boulevard) and portions of the Central Core (south of 15th Street/Stillman Boulevard and east of Fosters Ferry Road).

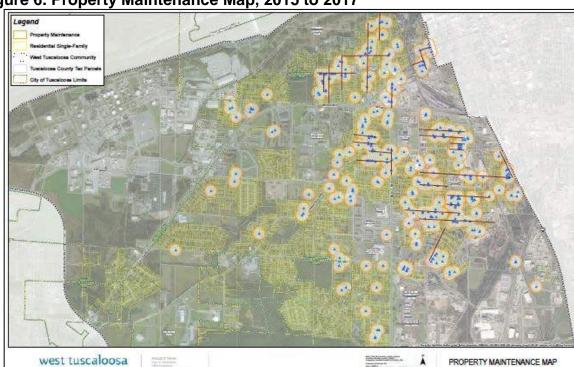
Figure 6. Property Maintenance Map, 2015 to 2017

Throughout the Tuscaloosa Study Area, there are conditions related to the lack of maintenance and abandonment of houses and buildings. At the time of our site visit, 21 properties in the West Tuscaloosa Study Area were scheduled for demolition. Three of those were demolitions necessitated by property fires. From 2015 to 2017, the City issued approximately 325 property maintenance cases in the West Tuscaloosa Study Area, as shown in Figure 6.

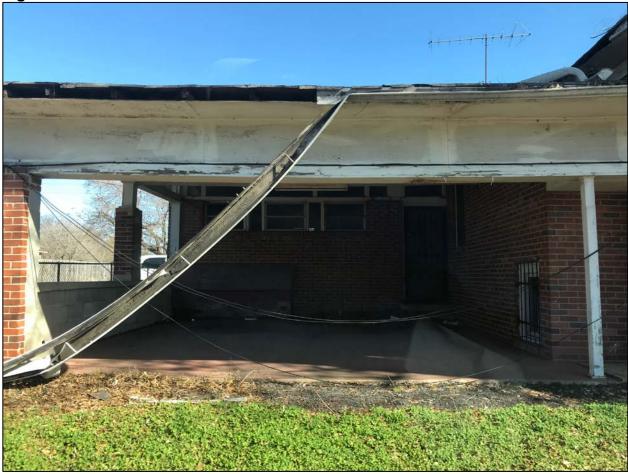
The Consultant Team documented several homes, abandoned and occupied, which displayed significant levels of disrepair.

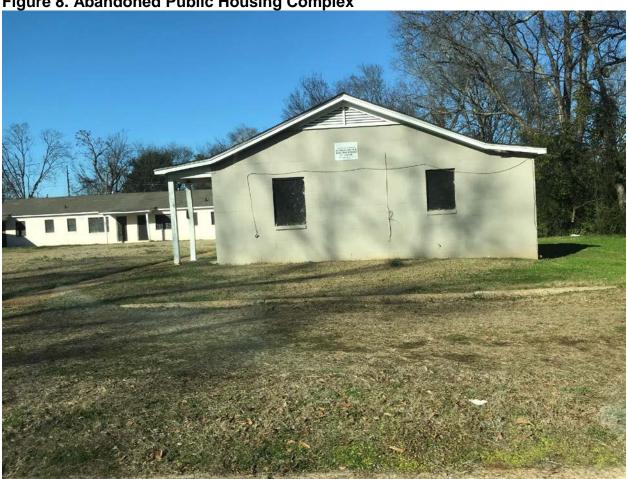
Abandoned apartment complexes and large buildings, such as this vacant public housing project on 17th Street, create a neighborhood eyesore and are an underutilization of large parcels that could be well-suited for redevelopment.

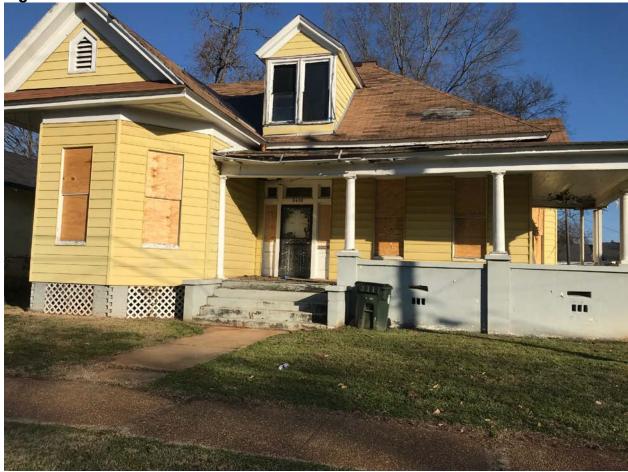
During our site visit, we documented several homes that appear to have structural and historical value. While boarded up, the property appears tidy and could be a good investment for those interested in restoring historic homes. There is evidence of this type of rehabilitation occurring throughout the Study Area.

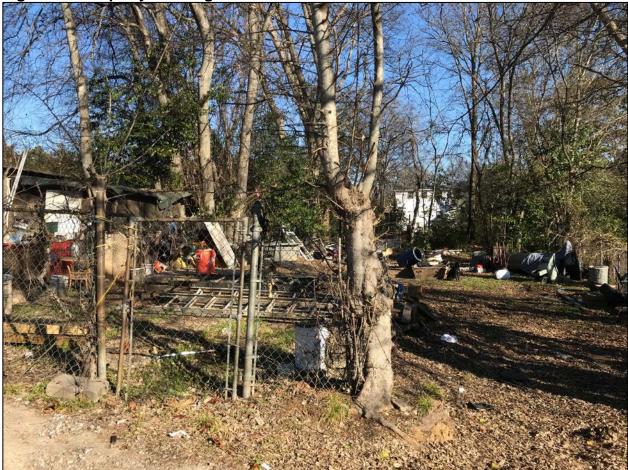
Properties with abandoned or dilapidated buildings and accumulated trash and debris create a variety of public health and safety issues for the surrounding area.

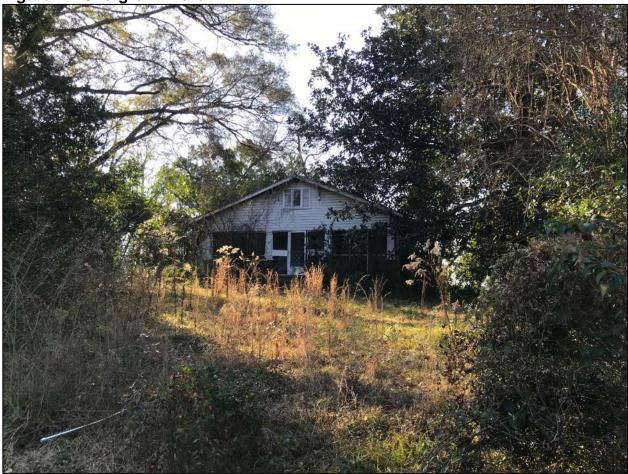
Properties that are not well-maintained, such as this overgrown yard, present significant public safety and public health issues for the surrounding area. Overgrown properties in combination with vacant or abandoned home sites can provide a haven for mosquitos, rodents, or other vermin and opportunities for squatters or places for illegal activities to occur.

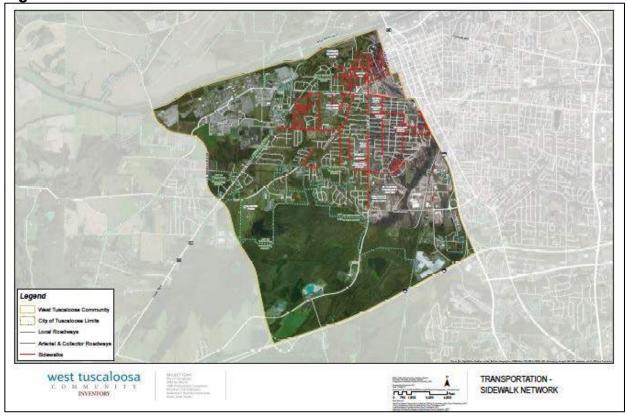
Figure 14. Sidewalk Network

As depicted in the Figure 14 below, the West Tuscaloosa Study Area suffers from a fragmented sidewalk network. Many residents interviewed during the West Tuscaloosa project's public engagement activities stated that they would like to be able to walk through their neighborhoods but feel unsafe doing so without sidewalks. In some instances, sidewalks may exist but are in poor condition.

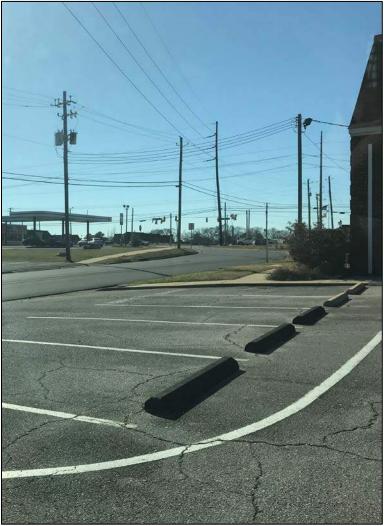
In addition to the discussions and photos provided above, there are properties, buildings, and conditions that contribute to visual blight. While these conditions of visual blight may not arise to the level of harming public health, safety, and welfare, they contribute to an overall appearance of disinvestment and of an economically depressed area.

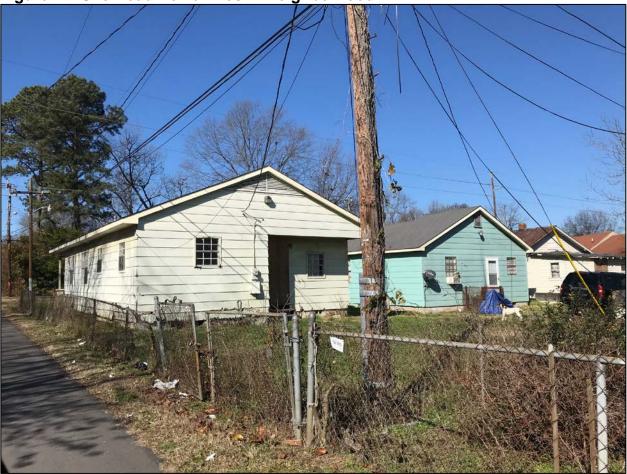
Throughout the West Tuscaloosa Study Area, the commercial and neighborhood views are dominated by a proliferation of powerlines and utility poles. There is also litter along the roadway.

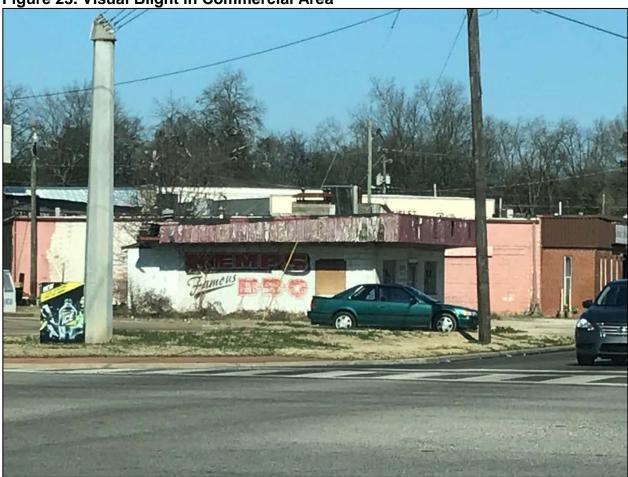
This commercial property at a prominent intersection contains many conditions of visual and physical blight, including an abandoned building, proliferation of utility poles and powerlines, unkempt landscaping, litter, and illegal signs.
